ANALYSIS OF THE PACOIMA DAM ACCELEROGRAM—SAN FERNANDO, CALIFORNIA, EARTHQUAKE OF 1971

BY M. D. TRIFUNAC AND D. E. HUDSON

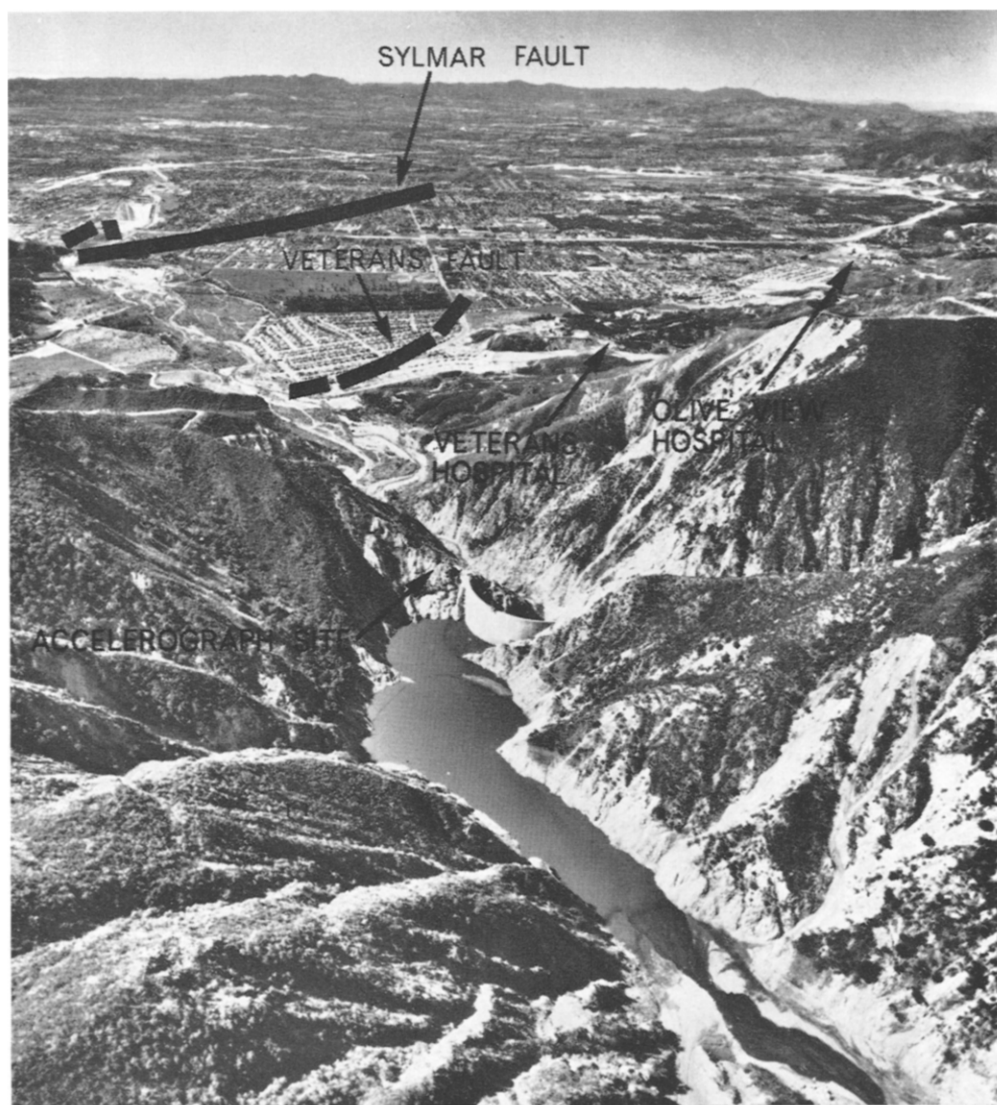
FIG. 3. Oblique aerial view looking southwest over the Pacoima Dam site.

Figure 3 shows an oblique aerial photograph looking south over the Pacoima Dam site with the San Fernando Valley in the distance. The location of the AR-240 accelerometer at Pacoima Dam is shown, and the locations of the two heavily-damaged hospitals are indicated in the background. Figure 4 shows a close-up view of the dam, with the location of the accelerometer on a rocky spine adjacent to the dam abutment

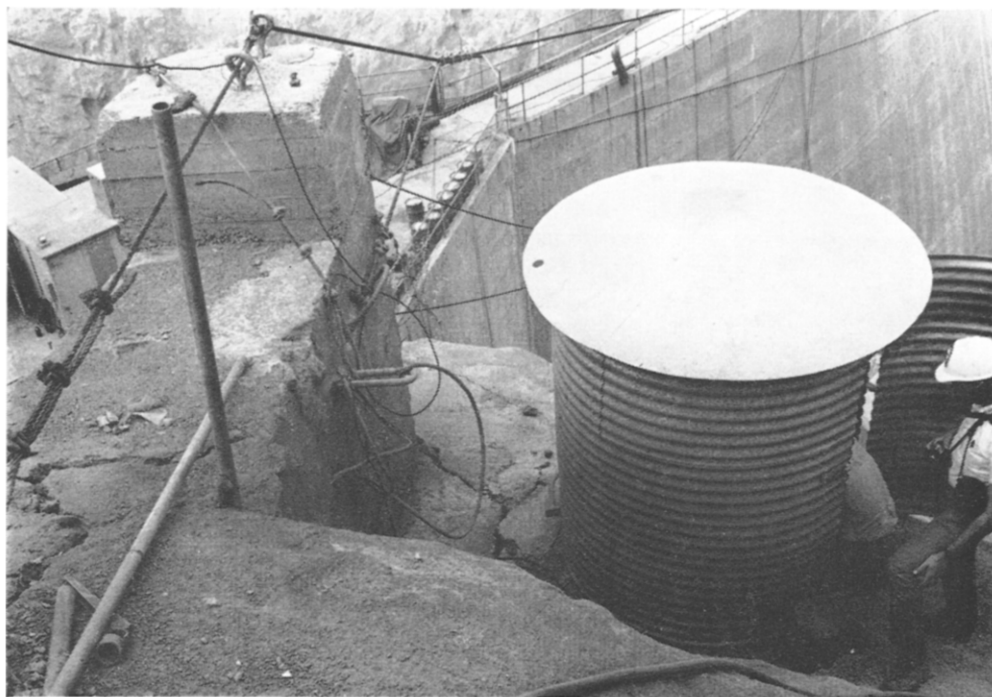
FIG. 6. View of the dam and the instrument site.

indicated. Figure 5 shows a view of the circular instrument house seen from below on the dam, and Figure 6 is a view of the dam and the instrument house from above looking north. In both of these figures, extensive cracking of the gneissic granite-diorite rock will be noted. Many of the cracks penetrate through the smooth gunite coating into the rock below.
